Discontinuity survey and brittle fracture characterisation in open pit slopes using photogrammetry

Zack Tuckey, Justine Paul and Jeff Price

This paper was first presented at the Asia Pacific Slope Stability in Mining Conference in Brisbane on September 6-9, 2016

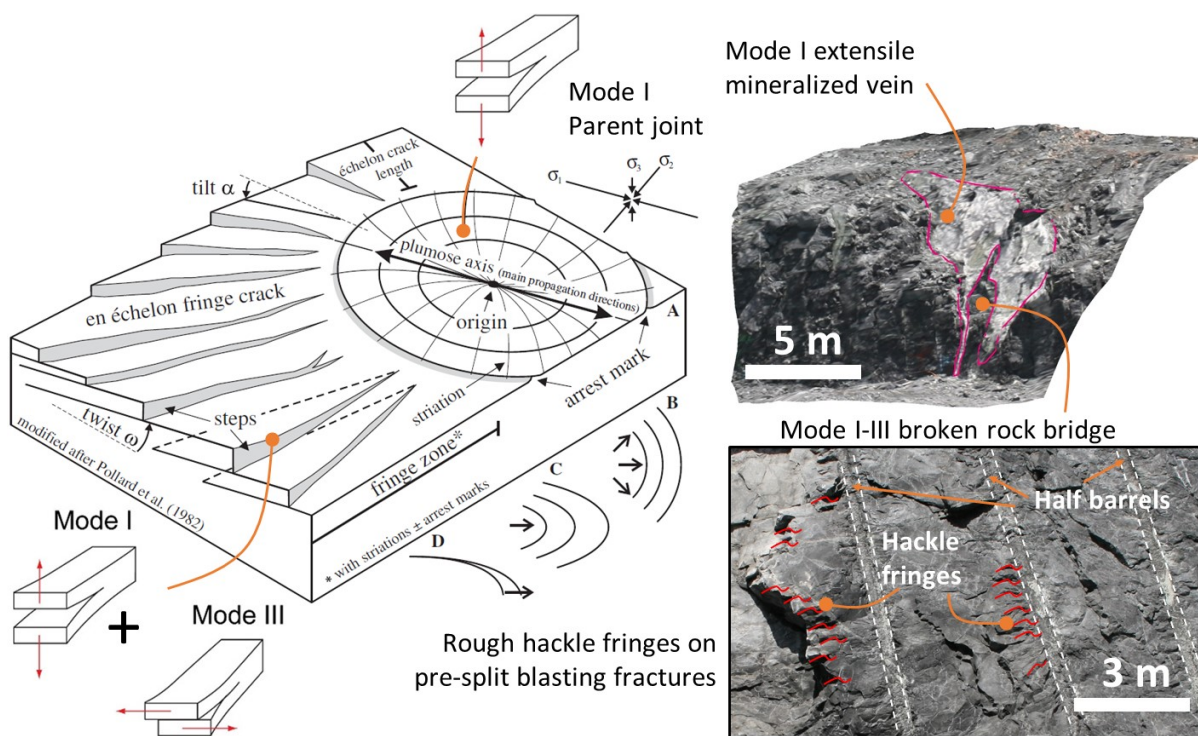
Figure 1 Conceptual application of fractography mapping (modified after Ziegler, 2014)

Fractography is the study of fracture surface morphology, and it can reveal details about the fracture formation conditions, notably (1) the stress conditions at the time of fracture, and (2) the speed of fracture propagation, whether slow and stable (attributed to most geological processes), or fast and unstable (attributed to blasting damage). Many experimental fractography studies have been undertaken using metals, glass, and plastics; however, rock fractography is less established (Ameen, 1995). We suggest that basic field scale fractography interpretation may provide useful insight into fracture formation conditions in open pit slopes, and the role of tensile cracking in rock mass behaviour. Figure 1 illustrates a conceptual diagram of fractography markings on sheet joints in granite, by Ziegler (2014), and conceptual interpretation of two fractures from the current study site: one extensile (mode I) mineralized vein, with a rock bridge broken by blasting, and a tensile, pre-split blasting induced fracture with rough hackle fringes indicating rapid loading and unstable fracture propagation.

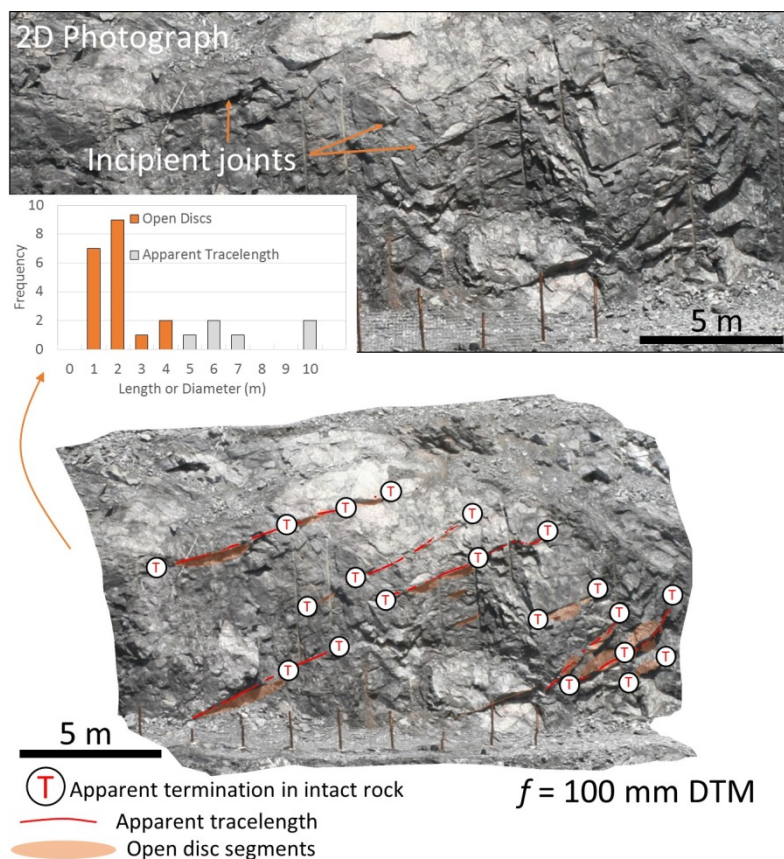
Figure 2 Incipient joints with termination in intact rock at the current study site

We recorded evidence of incipient joints wherever intermittent, coplanar trace patterns coincided with joint terminations in intact rock, identifying several apparently incipient joint sets likely retain cohesion and tensile strength from intact rock bridges. In these incipient joint sets, the full apparent trace length mapped using 3D polyline features can be compared with the diameter of the visible open discontinuity segments mapped as 3D discs; the results intuitively demonstrate that the apparent persistence of the open discontinuity segments can be much shorter than the length of complete inferred trace planes (Figure 2).

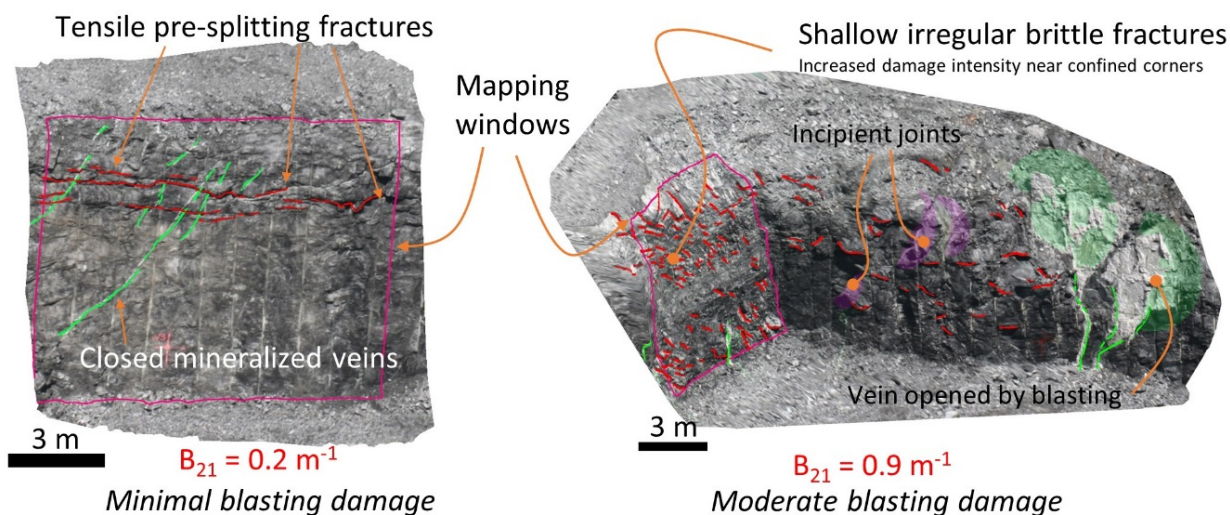
Figure 3 Blasting damage recorded in $f = 100$ mm photogrammetry survey

We identified blasting damage in our photogrammetry models using circular discs for incipient discontinuities broken open by blasting, and irregular polylines for low persistence, irregular tensile fractures (Figure 3). The intensity of irregular blasting induced fractures in 3D bench window maps can be expressed using an intensity parameter B_{21} analogous to the intensity of pre-existing discontinuities P_{21} .

We expect that most of the irregular brittle blast fractures are shallow, and do not extend far behind the slope face; however, we suggest that the aerial intensity of blasting fractures expressed using the B_{21} parameter may provide a useful starting point for quantitative comparison of the local severity of brittle blasting damage in different bench faces.

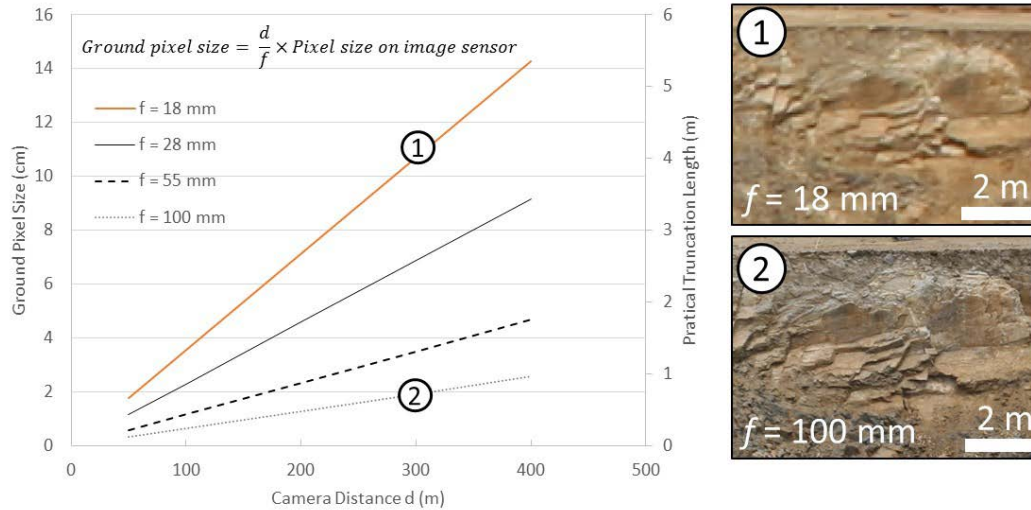
Figure 4 Typical variation in ground pixel size and practical truncation length for a Canon EOS 30D

Figure 4 illustrates the linear relationship between ground pixel size and camera distance, with a secondary vertical axis delineating the suggested practical truncation length for discontinuity mapping; features smaller than the truncation length are ignored. We achieved a truncation limit of about 250 mm in DTMs constructed from long-range $f = 100$ mm photographs. However, the peak frequency in our mapping dataset occurs for discontinuities with fitted disc diameter between 1 m and 2 m, reflecting scale bias: we focused first on the most persistent discontinuities, and then mapped progressively smaller structures until further mapping became impractical due to time constraints and model resolution.

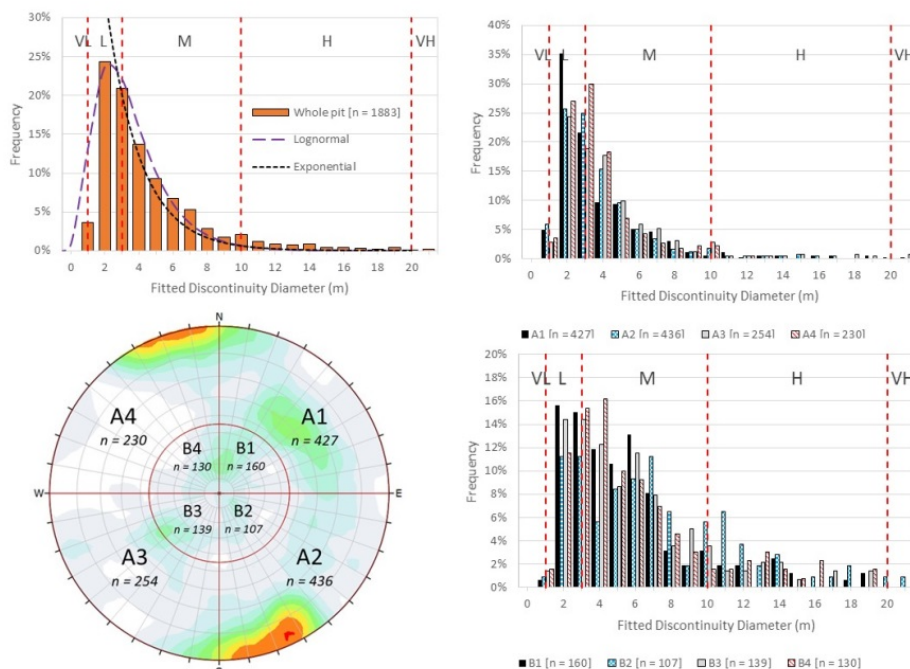
Figure 5 Normalized frequency of discontinuity diameter from photogrammetry dataset (n = 1883)

Figure 5 shows normalized frequency of fitted discontinuity diameter for the combined dataset, along with distributions for eight artificial joint sets: A1 to A4 encompass steep to moderately dipping discontinuities; sets B1 to B4 comprise moderately dipping to horizontal discontinuities. The results for the artificial joint sets show how the data can be used to characterise persistence for different joint sets with respect to the ISRM (1978) recommended categories, ranging from very low (VL) to very high (VH). For anonymity, the dataset includes measurements from all different geotechnical domains around the pit; we emphasize that the structural trends are not representative of geotechnical conditions in any one geotechnical domain.

The data seems well fitted to a lognormal distribution for trace lengths up to 20 m, which captures the reduction in frequency for low persistence joints with diameter less than 1 m, approaching the truncation limit. Alternatively, a negative exponential distribution can be used to reflect the real world expectation of exponentially increasing frequency of discontinuities with reducing size, approaching infinity as persistence reduces towards the scale of microcracks.

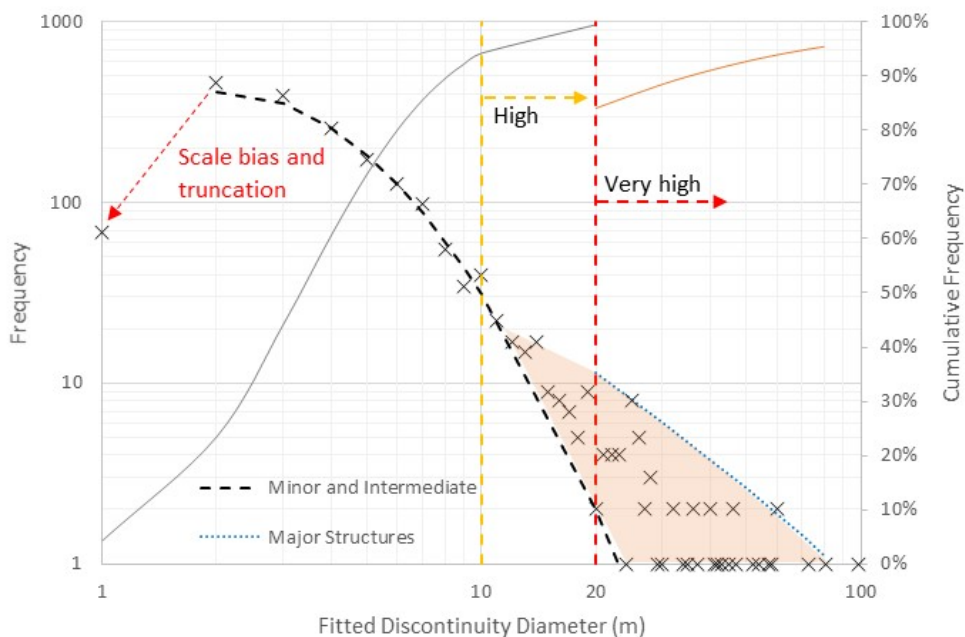
Figure 6 Lognormal plot of fitted discontinuity diameters including minor and major structures

When the frequency data are plotted on logarithmic axes, more than one persistence-frequency relationship can be discerned (Figure 6). One lognormal relationship provides a good lower-bound fit for minor and intermediate scale structures, with persistence less than 10 m; the cumulative frequency for this fitted line indicates 100% of structures are smaller than 20 m. However, between persistence of 10 m and 20 m, the data become more scattered, and we have indicated an upper-bound lognormal function to capture the frequency of major structures with very high persistence. The upper-bound cumulative frequency relationship for the population of interpreted major structures suggests that about 15% of discontinuities in this population may have persistence exceeding the 20 m “very high” threshold from the ISRM guidelines.

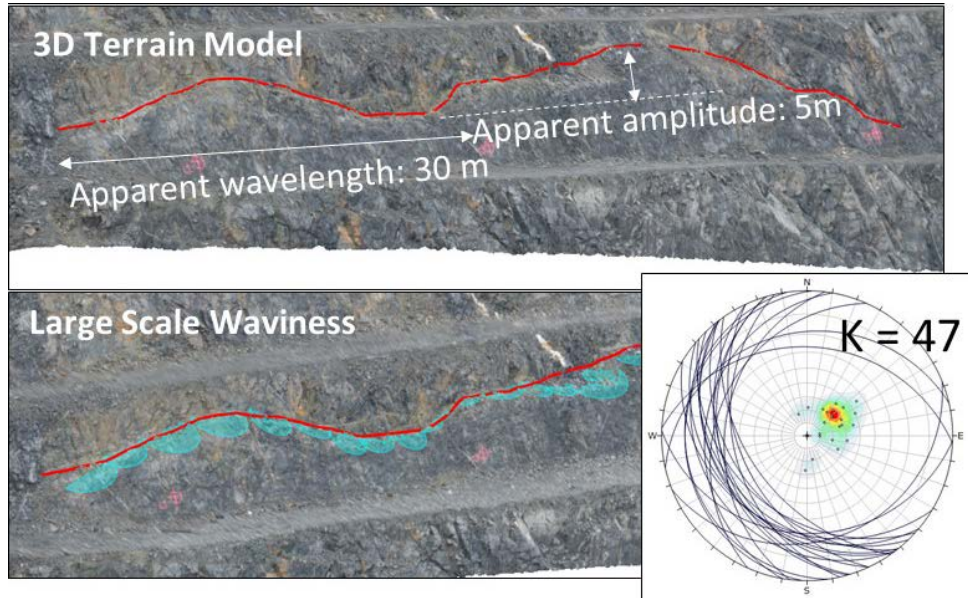
Figure 7 Waviness of a very high persistence, undulating discontinuity

Once the most persistent discontinuities relevant to slope stability are identified, targeted detailed photogrammetry mapping of each major discontinuity can help to characterise surface morphology. Understanding the waviness (first order roughness) of major discontinuities is particularly important for shear strength estimation in multi-bench, inter-ramp, or overall slopes scale stability analysis. The 3D models produced from photogrammetry provide excellent opportunity to assess waviness of very persistent undulating discontinuities. We suggest that large scale undulating discontinuities can be more fully described using polylines to measure trace length, apparent amplitude, and apparent wavelength, and regularly spaced planar discs fitted along the strike length of the discontinuity to characterise the variation in local orientation for derivation of waviness angle, for example by using a Fisher K constant (Figure 7).

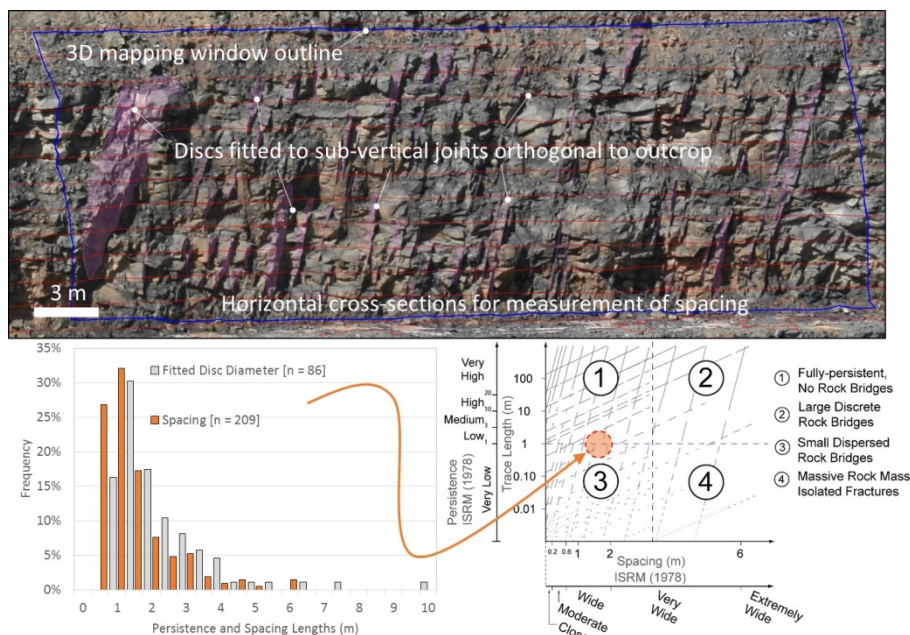
Figure 8 Digital bench face map with good conditions for measurement of spacing and persistence

We carried out targeted bench scale photogrammetry window mapping in order to investigate trends in discontinuity persistence and fracture intensity, and to conceptually investigate the role of intact rock bridges separating discontinuity tips. Figure 8 shows one example window, approximately 36.6 m wide and 12.8 m high, with an idealized flat surface area of 468 m² and 3D triangulated surface area of 550 m².

For this example we focus on one major joint set, locally steeply dipping and striking approximately orthogonal to the bench face. The joint set orientation provides ideal conditions for measuring discontinuity spacing. In total 86 joint segments were identified, and 209 spacing measurements were captured between the joint segments, along horizontal scanlines spaced at 1 m intervals. The intensity of pre-existing fractures ($P_{2,1}$) is 0.38 m^{-1} if discontinuity trace lengths are measured against the idealized 2D window surface area, or 0.32 m^{-1} if they are evaluated against the 3D triangulated surface area of the window. The peak frequency for open joint planes occurs for open discs with apparent persistence between 1 m and 2 m, however the sub-vertical fabric appears persistent, and inferred traces could be interpreted to extend the full height of bench, with rock bridges separating the tips of joints terminating in intact rock.

Figure 8 also includes a conceptual diagram relating discontinuity spacing and persistence according the ISRM guidelines, with four suggested domains for describing the content of intact rock bridges in a layered rock mass. With peak frequency of discontinuity spacing and persistence both typically in the range of 1 m to 2 m, this rock mass could be qualitatively characterised as transitional between conceptual domains 1 and 3. The sub-vertical joints are not fully persistent over the full bench height, and open discontinuity segments may be separated by zones of incipient microcracking or intact rock bridges with dimensions in the approximate range of 100 mm to 500 mm.

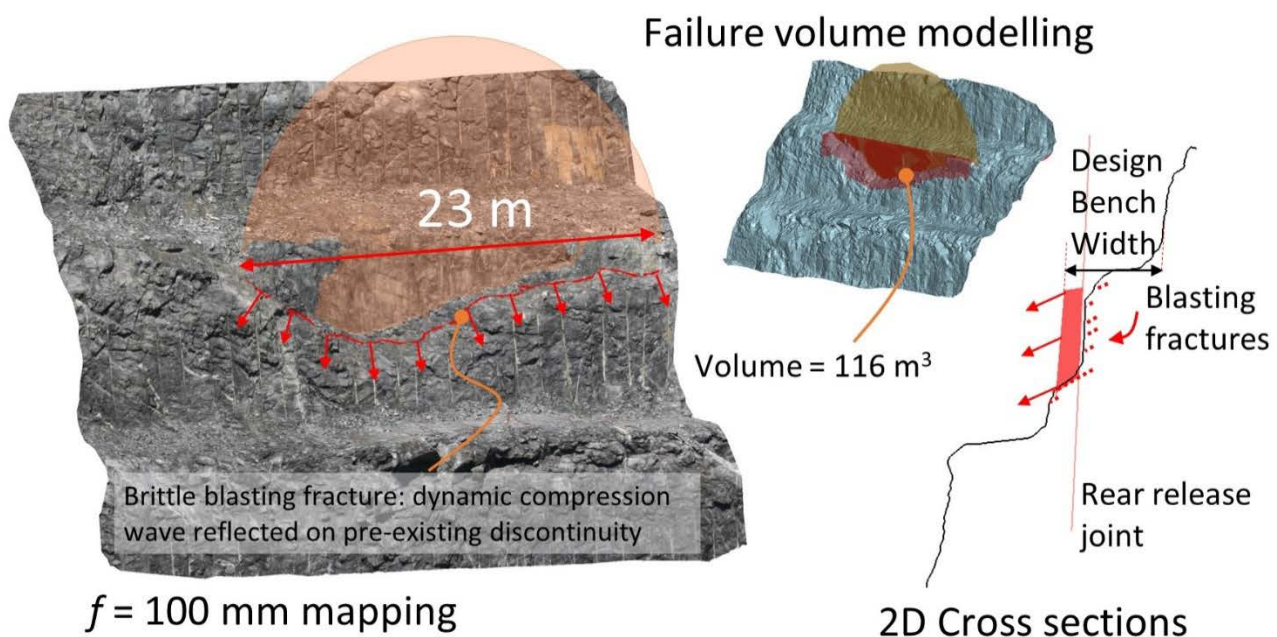
Figure 9 Interaction between pre-existing discontinuities and blasting induced damage

Pre-existing discontinuities can reflect the dynamic compression waves induced during blasting and limit the extent of blasting damage. In at least one instance we recorded zones of blasting-induced bench crest failure, bounded by a high persistence pre-existing discontinuity striking sub-parallel to the bench face (Figure 9). The photogrammetry models allowed us to measure the volume of blast-induced bench scale failures, and also to rapidly produce 2D cross sections for simplified limit equilibrium slope models, and for comparison of as-built versus design bench face angles and distribution of crest loss throughout the pit.

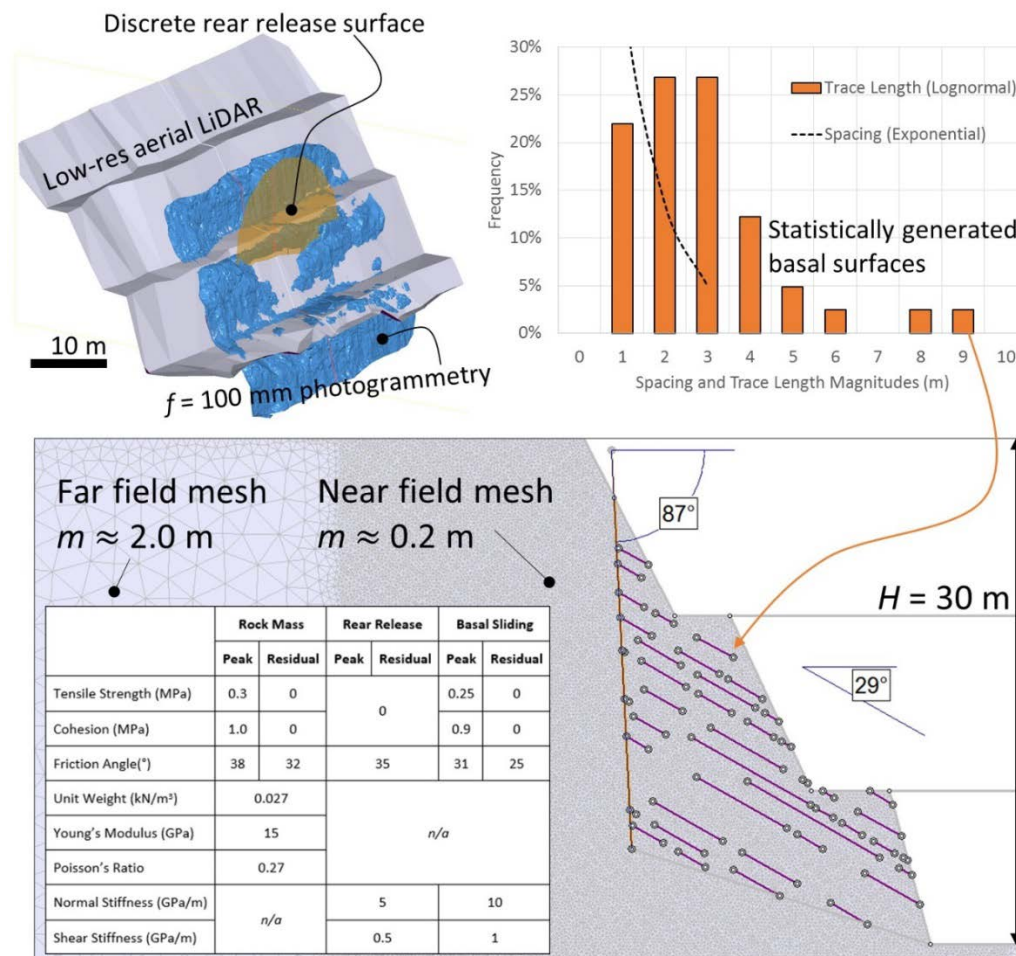
Figure 10 Conceptual FEM setup for bench scale simulation of bi-planar slope instability

The model simulates an approximately bi-planar step-path failure, with a discrete, steeply dipping rear release joint with very high persistence, and statistically generated basal sliding joints with mostly low to medium persistence and spacing between 1 m and 3 m. Joint termination conditions are open, which allows for some limited differential displacements to occur along the joint elements (Figure 10).

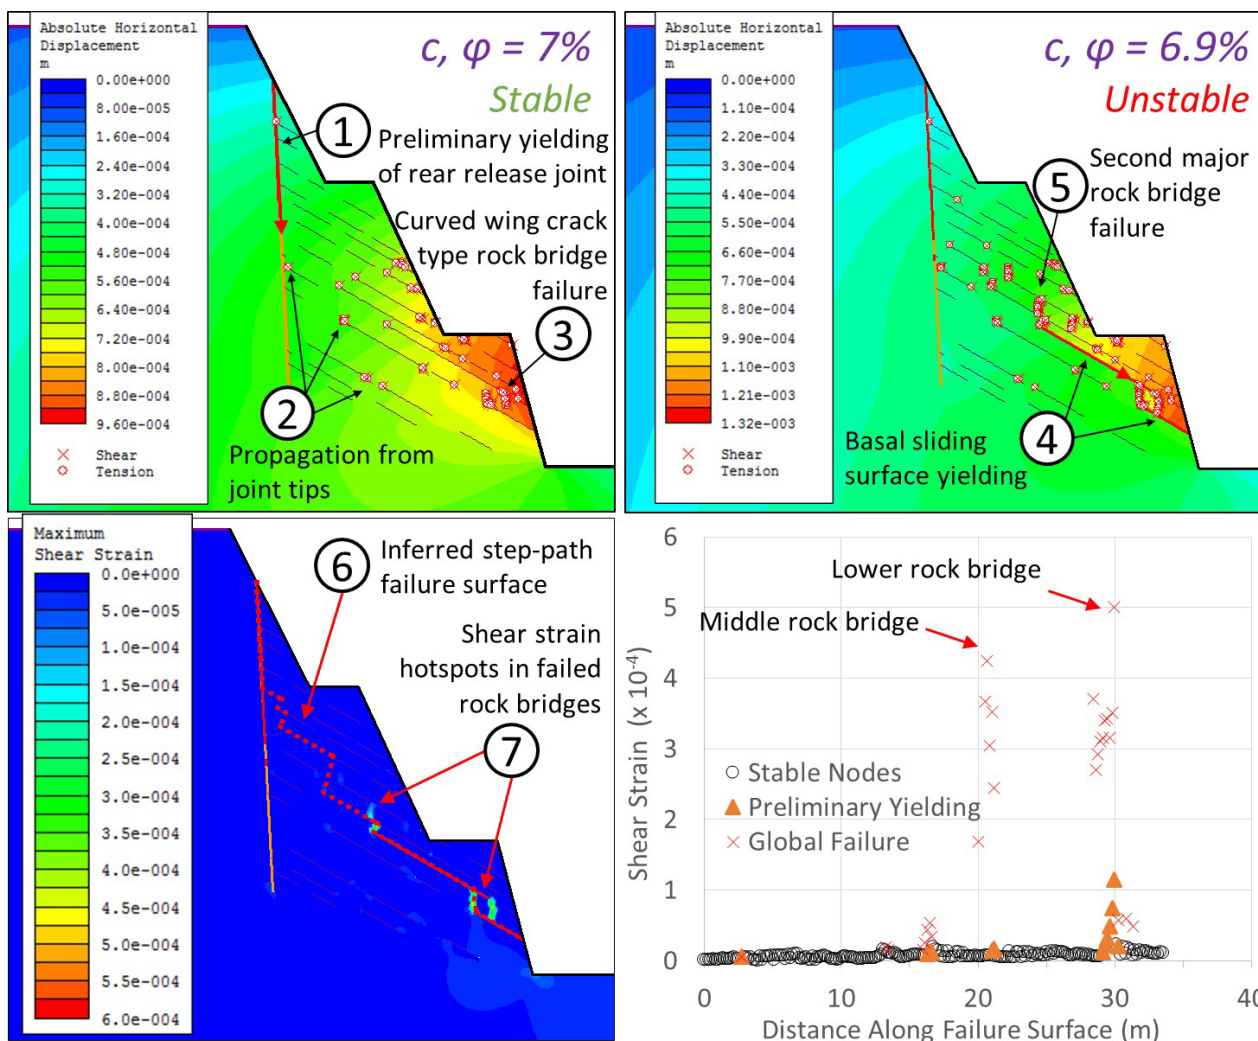
Figure 11 Conceptual FEM results highlighting progressive step-path failure development

The results show that global instability (indicated by non-convergence of the explicit force-balance solution process) occurs when the cohesion and tensile strength of the basal sliding joints are reduced to below about 7% of their original values, or cohesion of 63 kPa and tensile strength of 18 kPa (Figure 11). Even under stable conditions, some preliminary yielding of the rear release surface occurs, along with fracture propagation from the tips of some basal sliding joints, and incipient rock bridge failure near the toe of the slope.

When the cohesion and tensile strength of the basal joint are reduced below 7% of their original values, the incipient rock bridge failure near the toe of the slope propagates to form a continuous step-path, and a second major rock bridge failure occurs in the middle of the slope. Because Phase2 is limited to small displacements occurring just at the onset of global instability, the shear strain along most of the inferred step-path failure surface is generally small ($<< 1 \times 10^{-4}$), however locally elevated shear strain hotspots (5×10^{-4}) correspond to the two major rock bridge failures.

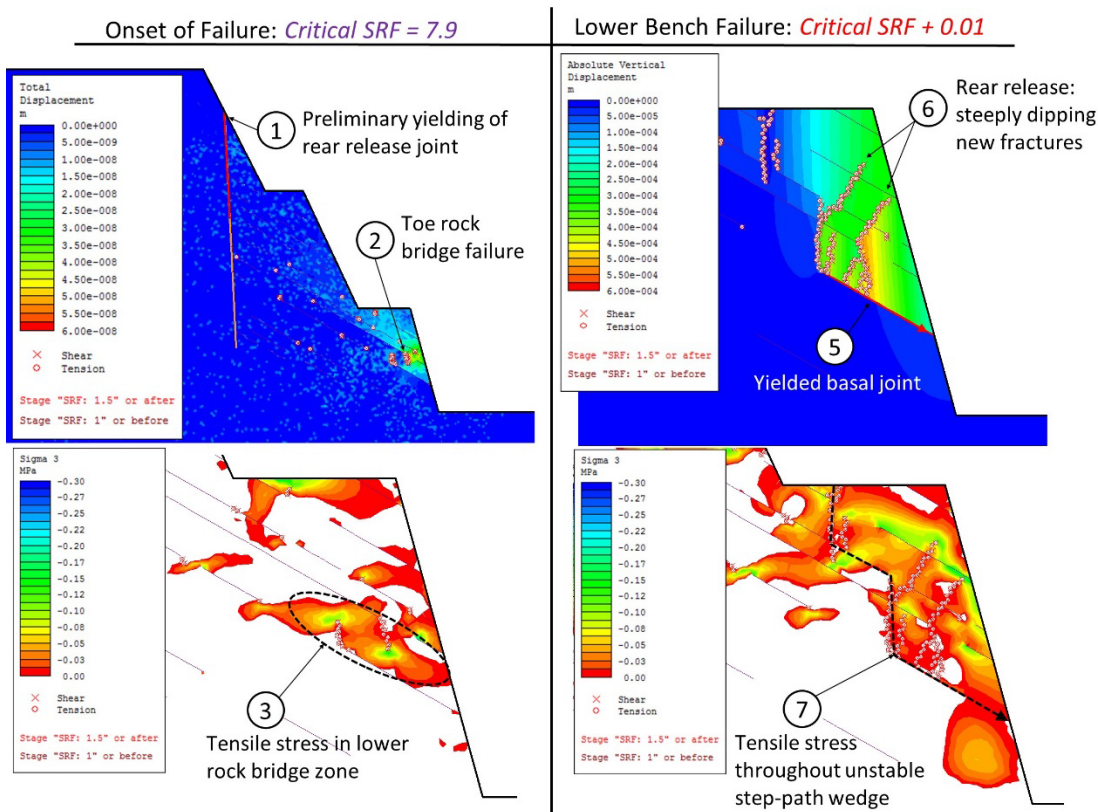
Figure 12 Alternative failure mechanism resulting from SSR analysis

We also carried out a Shear Strength Reduction (SSR) analysis, which solves for a critical Strength Reduction Factor (SRF), a proxy for Factor of Safety that describes the shear strength reduction required to induce instability. For this model the results show a very high SRF value of 7.9, suggesting high confidence in the stability of a slope with these input parameters. However, the SSR routine does not degrade cohesion and tensile strength before mobilising friction: the routine automatically reduces discontinuity friction angles, along with cohesion and tensile strength; consequently, a different instability mechanism occurs. Instead of a multi-bench step-path failure, the instability is confined to the lower bench, where steeply dipping rock mass fractures propagate and form rear release surfaces for a bench scale step-path wedge (Figure 12).

Because the SSR analysis simultaneously reduces cohesion and friction angle, we suggest that it is not well suited to simulating the progressive deterioration of cohesion and tensile strength that occurs along incipient discontinuities *before* frictional strength is mobilized. In this case, the SSR analysis predicts a critical failure mechanism characterised by step-path instability confined to the lower bench. The result could be non-
