## **Closure at the San Manuel Plant Site How Closure Aligned with the Goal of Environmental Sustainability<sup>1</sup>**

Dawn H. Garcia<sup>2</sup>, P.G., and Terry Braun<sup>3</sup>, P.E.  
SRK Consulting (U.S.), Inc.

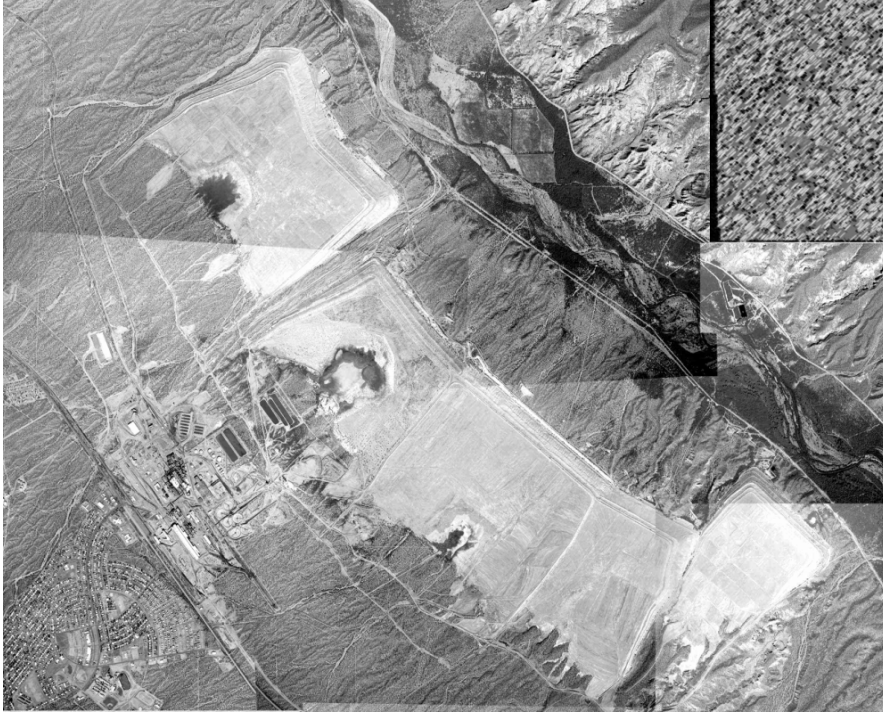
BHP worked within the Pinal County Comprehensive Plan (2005) as well as local economic development agencies to identify appropriate land use options and opportunities for the Plant Site. In areas of former heavy industrial activity, BHP collaborated with the Arizona Department of Environmental Quality to establish appropriate soil remediation levels for site remediation. The operations are shown on Photo 1.

*Photo 1 San Manuel Plant Site Operations (Aerial view pre-closure)*

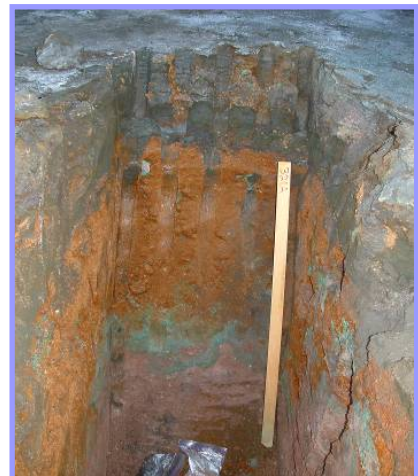
*Photo 2: Soil characterization trench*

contaminated soils within the Plant Area. Contaminated soils were generated within material staging areas as well as within areas of heavy industrial activity. In some cases, contaminated soils were located below fill materials (Photo 2). The primary soil contaminants are metals.

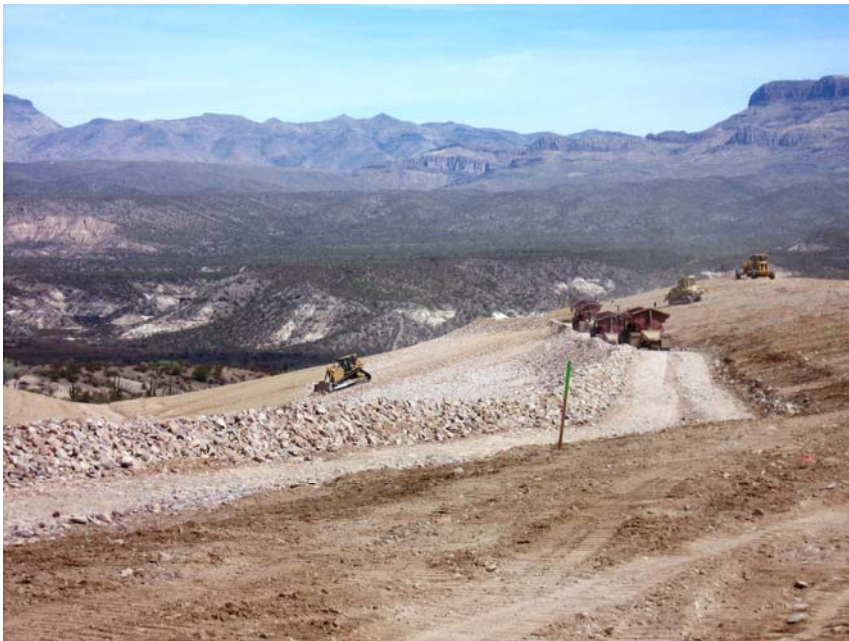
Stormwater runoff from the industrial area was captured on the tailings impoundments and then evaporated. Separate diversion berms and channels were constructed on the regraded and covered areas. The diversion berms and channels manage storm water and limit erosion through collection and diversion of storm water runoff from the covered area to natural drainages. Drainage patterns from the Plant Area towards the tailing impoundments will continue after closure of the Plant Area and Tailings Area; however, drainage from the Plant Area will be captured upgradient of the tailing impoundments in the clean water diversion channels and discharged off site (Photo 4).

*Photo 4: Installation of rock armor on 6 Dam*

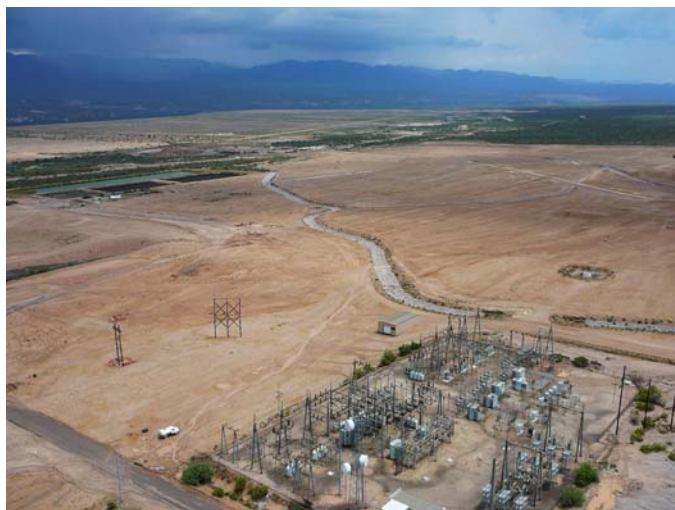
*Photo 5: View of former Plant Area (August 2007)*
